**Flood Control Project Maintenance
Levee Inspections**

Maintenance Issue Types Only, Levee Inspection Report By Mile - Fall 2018

Reclamation District No. 2031 Elliot

Waterway	Bank	Unit Miles	Inspection Start/End	Inspector
Unit No. 01 Stanislaus River	Left	7.07	10/29/2018 10/29/2018	Sterling York

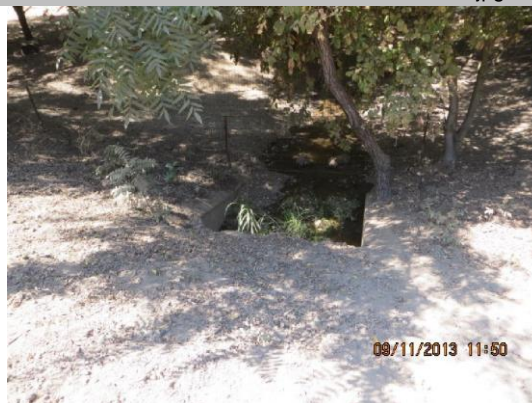
Photo 1 of 3 : UCIP_FA_2018_20092_34041.jpg

LM Start	1.78	Rating **	M	Issue No.	992
LM End	1.78	Issue Type +	Ma	Location *	
Category	Supplemental			GPS Latitude/Longitude	
				Start	End
Item	DWR UCIP LMA Responsibility			37.696943 °	37.696943 °
				-121.177470 °	-121.177470 °
DWR ID	20447				
Comment Code					
Inspector Comment					
FS_ID:20092					
DS_ID:20447					
EP_NO: N/A					
Repair Type: Non-Urgent					
Crossing Status: Found					
UCIP Comments: Silt buildup at inlet and outlet.					
FIELD_STRUCT_DESC: 2 of 2: 24-inch corrugated metal drainage pipe through the levee, 9.5 feet below the crown. Concrete U-shaped headwalls on both ends. Flap gate on the waterside (WS) end. Installed by USACE in 1966. [Additional Reference(s): DWR Levee Log, 2005. USACE San Joaquin O&M Manual 4, June 1968, (HLM 1.80)].					
FS Date: 9/11/2013

Concrete U-shaped headwall on WS toe.

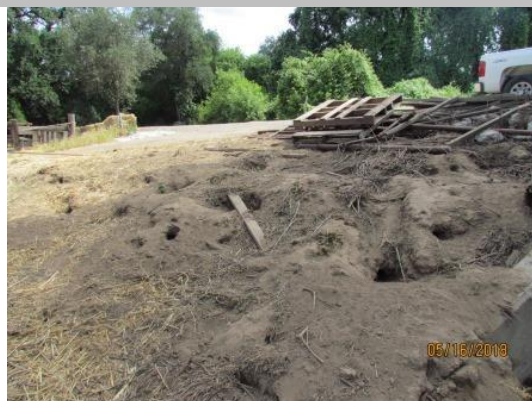
Photo 1 of 1 : FA_2018_RD2031_307_49_20180918_00027.jpg

View of the waterside where several squirrel holes are and active rodent activity.

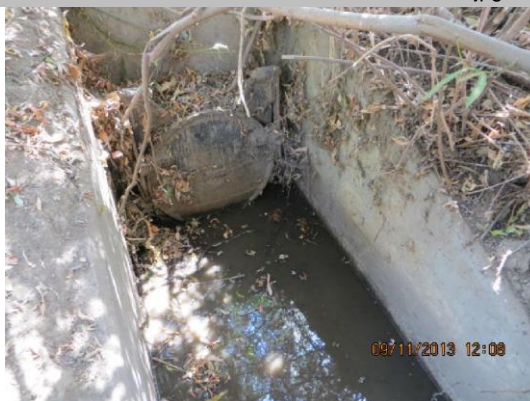
Photo 1 of 3 : UCIP_FA_2018_20110_34078.jpg

LM Start	2.39	Rating **	A/W	Issue No.	994
LM End	2.39	Issue Type +	Ma	Location *	
Category	Supplemental			GPS Latitude/Longitude	
				Start	End
Item	DWR UCIP LMA Responsibility			37.688676 °	37.688676 °
				-121.179622 °	-121.179622 °
DWR ID	20449				
Comment Code					
Inspector Comment					
FS_ID:20110 DS_ID:20449 EP_NO: N/A Repair Type: No Action Needed Crossing Status: Found UCIP Comments: FIELD_STRUCT_DESC: 24-inch corrugated metal drainage pipe through the levee, 3 feet below the crown. Concrete U-shaped headwall on the waterside (WS) end. Flap gate on the WS end. 5-foot by 5-foot concrete riser with pump on the LS toe. Likely that concrete riser is inlet for drainage pipe. [Additional Reference(s): DWR Levee Log, 2005. USACE San Joaquin O&M Manual 4, June 1968, (HLM 2.41)]. FS Date: 9/11/2013

Flapgate and concrete headwall on WS toe.

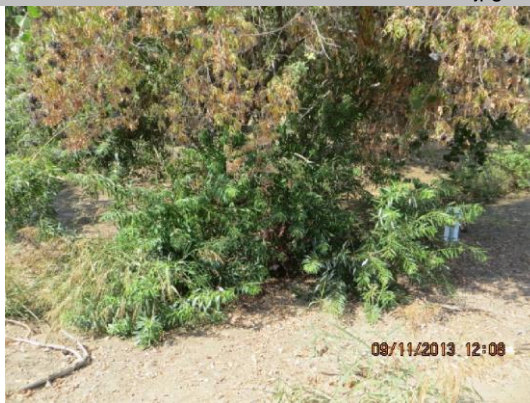
Photo 2 of 3 : UCIP_FA_2018_20110_34077.jpg

Vegetation covers outlet of pipe on WS slope.

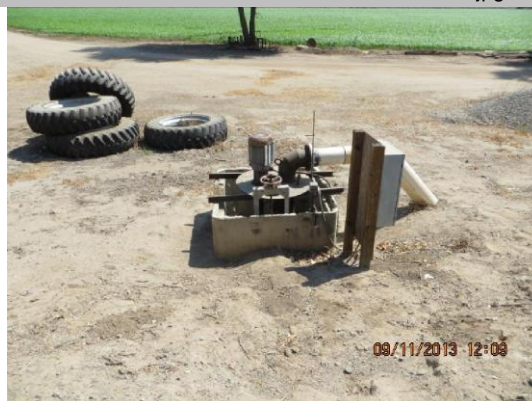
Photo 3 of 3 : UCIP_FA_2018_20110_34076.jpg

5'X5' concrete riser with pump on LS toe.

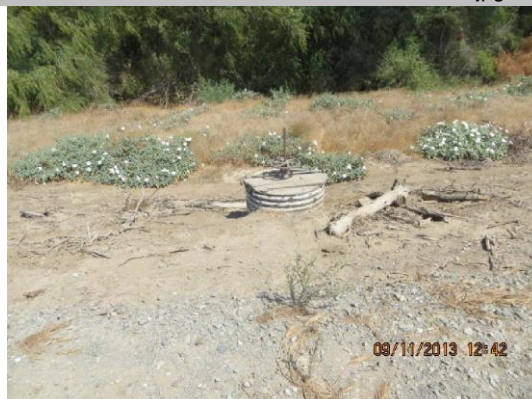
Photo 1 of 3 : UCIP_FA_2018_20449_34506.jpg

LM Start	3.08	Rating **	M	Issue No.	996	
LM End	3.08	Issue Type +	Ma	Location *		
Category	Supplemental			GPS Latitude/Longitude		
				Start		End
Item	DWR UCIP LMA Responsibility			37.688297 °		37.688297 °
				-121.190865 °		-121.190865 °
DWR ID	20451					
Comment Code						
Inspector Comment						
FS_ID:20449						
DS_ID:20451						
EP_NO: N/A						
Repair Type: Non-Urgent						
Crossing Status: Found						
UCIP Comments: Pipe appears to be abandoned and if so should be done so properly.						
FIELD_STRUCT_DESC: *ABANDONED* 24-inch corrugated metal drainage pipe through the levee, 14 feet below the crown. Slide gate in a 36-inch corrugated metal pipe (CMP) riser on the waterside (WS) slope. [Additional Reference(s): DWR Levee Log, 2005. USACE San Joaquin O&M Manual 4, June 1968, (HLM 3.11)].						
FS Date: 9/11/2013

Slide gate in CMP riser on WS slope.

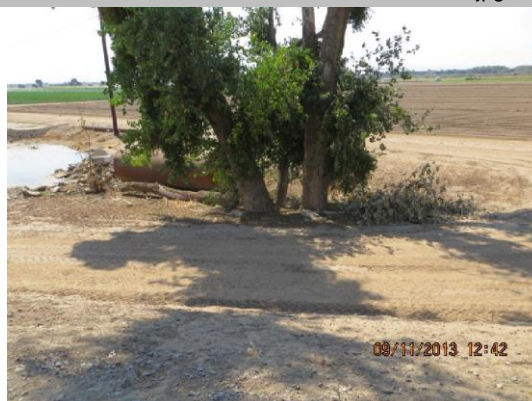
Photo 2 of 3 : UCIP_FA_2018_20449_34505.jpg

Pipe not visible on LS toe.

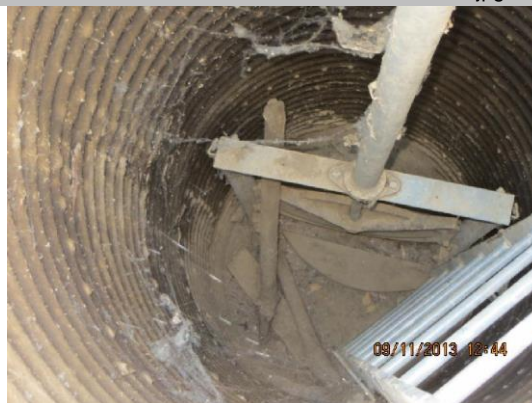
Photo 3 of 3 : UCIP_FA_2018_20449_34504.jpg

Slide gate in CMP riser on WS slope.

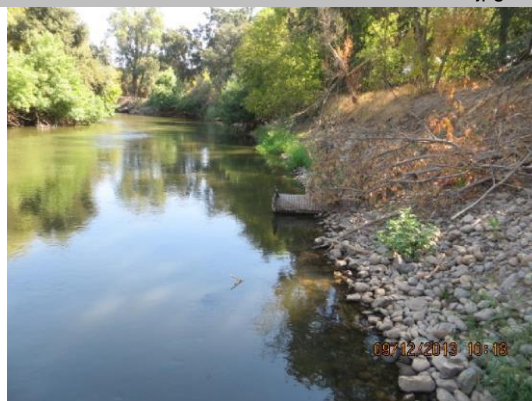
Photo 1 of 2 : UCIP_FA_2018_23064_39200.jpg

FS_ID:23064
DS_ID:20478
EP_NO: N/A
Repair Type: Non-Urgent
Crossing Status: Found
UCIP Comments: Good candidate for video inspection.
FIELD_STRUCT_DESC: 24-inch corrugated metal drainage pipe through the levee, 5.5 feet below the crown. Flap gate visible at the waterside (WS) toe. [Additional Reference(s): USACE San Joaquin O&M Manual 4, June 1968, (HLM 3.7), listed as a 20-inch pipe, 3.9 feet below the crown].
FS Date: 9/12/2013

CMP pipe and flapgate visible at WS toe.

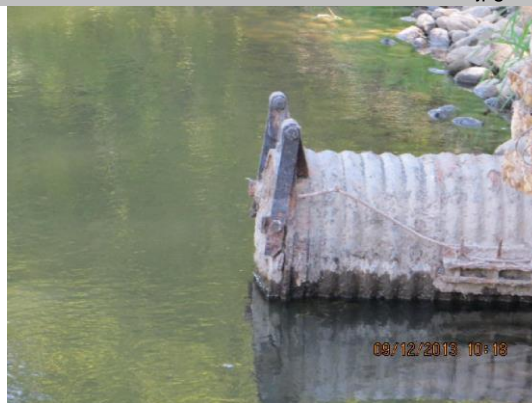
Photo 2 of 2 : UCIP_FA_2018_23064_39199.jpg

CMP pipe and flapgate visible at WS toe.

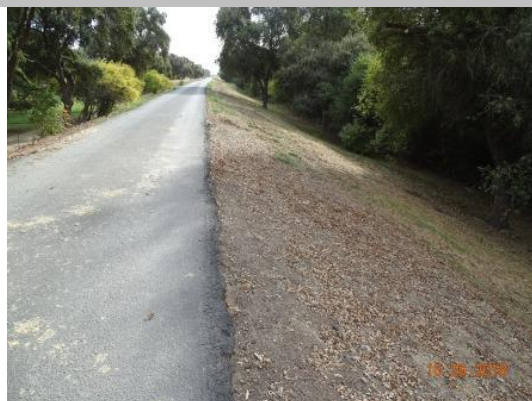
Photo 1 of 1 : FA_2018_RD2031_308_16_20181108_00048.jpg

View looking upstream waterside of the well maintained annual vegetation, Fall 2018.

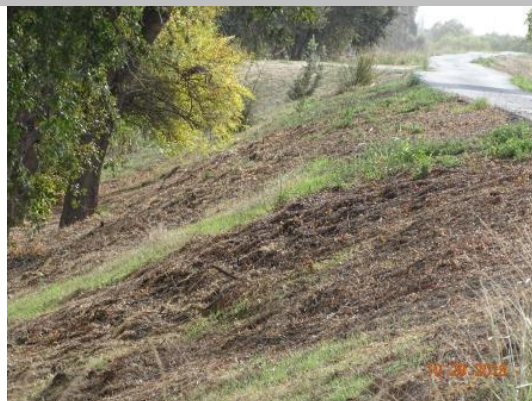
Photo 1 of 1 : FA_2018_RD2031_308_15_20181108_00050.jpg

LM Start	0.16	Rating **	A	Issue No.	15
LM End	5.96	Issue Type +	Ma	Location *	LS
Category	Earthen Levee			GPS Latitude/Longitude	
				Start	End
Item	Vegetation			37.659683 °	37.630752 °
				-121.233865 °	-121.159454 °
DWR ID	DWR_RD2031_02_f_2018_15				
Comment Code					
V1 : Control annual grass and weeds on the levee slopes and easements.					
Inspector Comment					
The annual vegetation is well maintained, Fall 2018.

View looking upstream landside of the well maintained annual vegetation, Fall 2018.

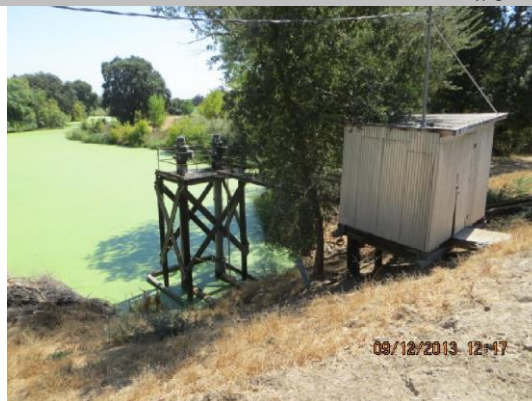
Photo 1 of 3 : UCIP_FA_2018_20703_34822.jpg

LM Start	0.22	Rating **	A/W	Issue No.	967	
LM End	0.22	Issue Type +	Ma	Location *		
Category	Supplemental			GPS Latitude/Longitude		
				Start	End	
Item	DWR UCIP LMA Responsibility			37.658888 °	37.658888 °	
				-121.234274 °	-121.234274 °	
DWR ID	20482					
Comment Code						
Inspector Comment						
FS_ID:20703						
DS_ID:20482						
EP_NO: N/A						
Repair Type: No Action Needed						
Crossing Status: Found						
UCIP Comments:						
FIELD_STRUCT_DESC: 1 of 2: 24-inch steel drainage pipe through the levee, 3.6 feet below the crown. Concrete U-shaped headwall on the waterside (WS) end. Flap gate on the WS end. Pump on pile structure on the landside (LS). [Additional Reference(s): DWR Levee Log, 2005. USACE San Joaquin O&M Manual 4, June 1968, (HLM 0.24)].						
FS Date: 9/12/2013

Pump on platform at LS toe.

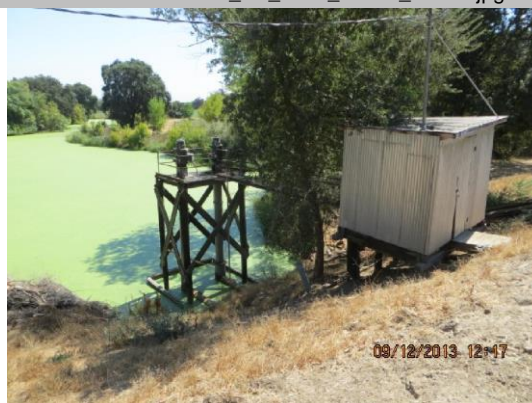
Photo 1 of 3 : UCIP_FA_2018_20704_34826.jpg

LM Start	0.22	Rating **	A/W	Issue No.	968
LM End	0.22	Issue Type +	Ma	Location *	
Category	Supplemental			GPS Latitude/Longitude	
				Start	End
Item	DWR UCIP LMA Responsibility			37.658875 °	37.658875 °
				-121.234280 °	-121.234280 °
DWR ID	20508				
Comment Code					
Inspector Comment					
FS_ID:20704 DS_ID:20508 EP_NO: N/A Repair Type: No Action Needed Crossing Status: Found UCIP Comments: FIELD_STRUCT_DESC: 2 of 2: 24-inch steel drainage pipe through the levee, 3.6 feet below the crown. Concrete U-shaped headwall on the waterside (WS) end, and a concrete headwall at the landside (LS) toe. Flap gate on the WS end. Pump on pile structure on the LS. [Additional Reference(s): DWR Levee Log, 2005. USACE San Joaquin O&M Manual 4, June 1968, (HLM 0.24)]. FS Date: 9/12/2013

Pump on pier on LS toe with shed at pump walkway.

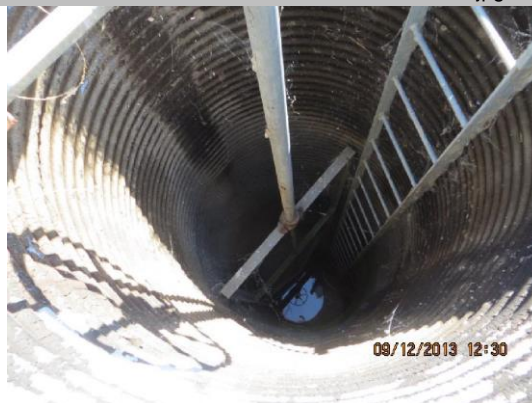
Photo 2 of 3 : UCIP_FA_2018_52629_34834.jpg

Slide gate in CMP riser on WS slope.

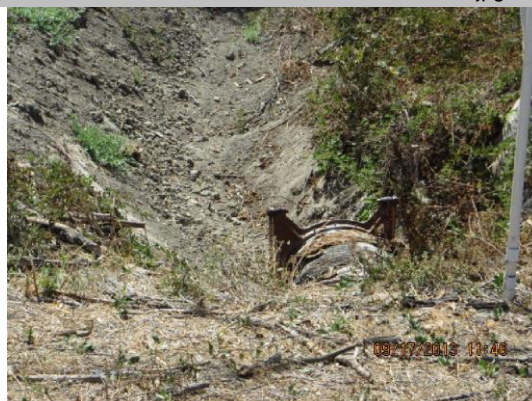
Photo 1 of 3 : UCIP_FA_2018_20723_34882.jpg

Flap gate on CMP pipe at WS toe.

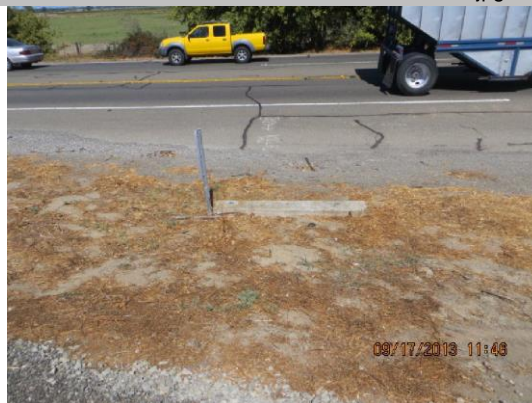
Photo 2 of 3 : UCIP_FA_2018_20723_34881.jpg

Concrete headwall on LS toe.

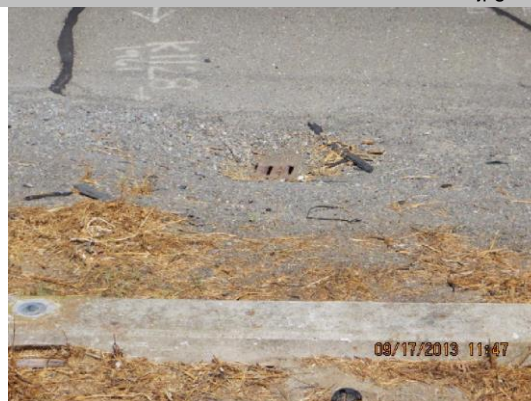
Photo 3 of 3 : UCIP_FA_2018_20723_34880.jpg

Drop inlet on LS toe.

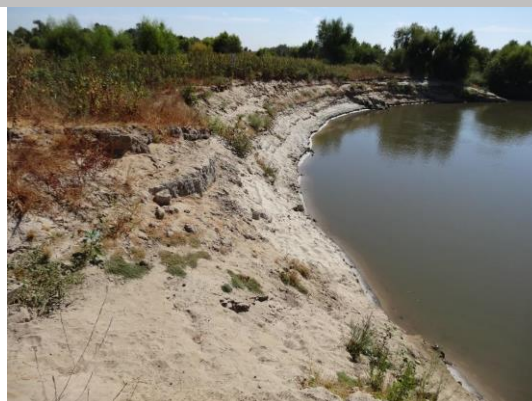
Photo 1 of 4 : FA_2018_RD2031_308_1_20180918_00001.jpg

Looking upstream of the erosion site.

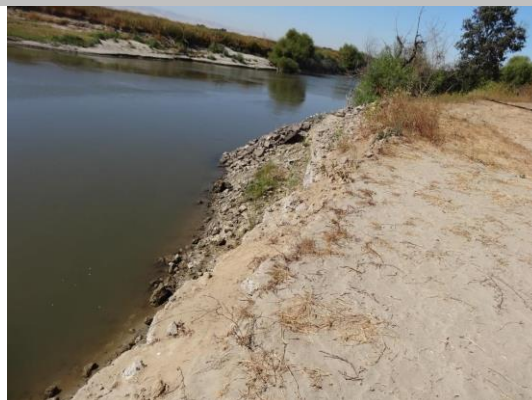
Photo 2 of 4 : FA_2018_RD2031_308_1_20180918_00002.jpg

Looking downstream of the erosion site.

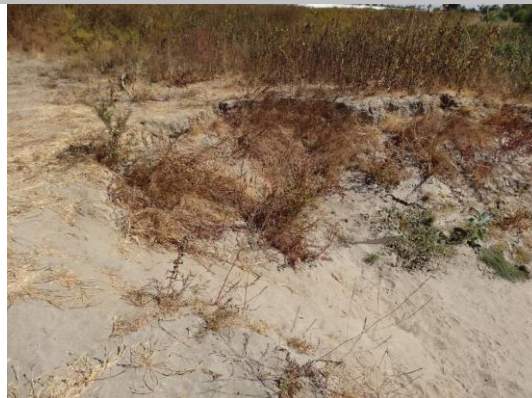
Photo 3 of 4 : FA_2018_RD2031_308_1_20180918_00003.jpg

Close view of the pocket erosion.

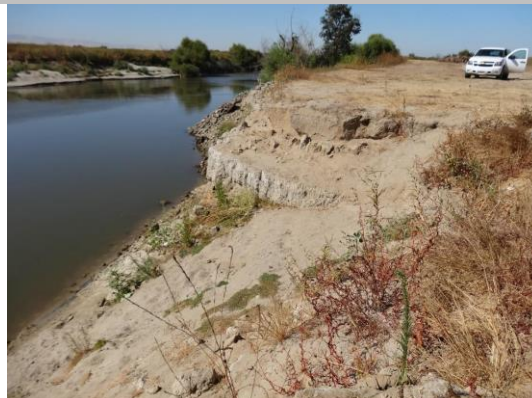
Photo 4 of 4 : FA_2018_RD2031_308_1_20180918_00004.jpg

Close view of the erosion.
